VENTILATION IN NEW HOMES

A report of site visit findings

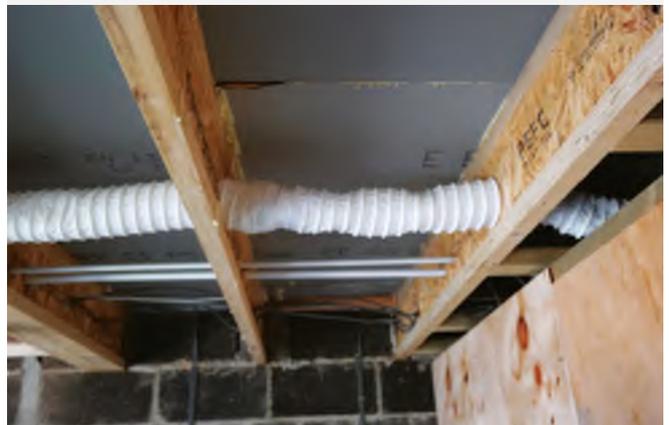
An example of a common issue found was flexible ducting being installed in place of rigid ducting, and long duct runs of over 5 metres with multiple bends. This happened either because the drawings used had missed specifying the type of ducting needed, and/or rigid ducting had been specified but the design was not followed on site or was found to be impractical to deliver by the site team.

Poor installation of flexible ducting leads to fans having to work harder to deliver the minimum ventilation rates required by Approved Document Part F of Building Regulations (ADF), and to systems being noisy.

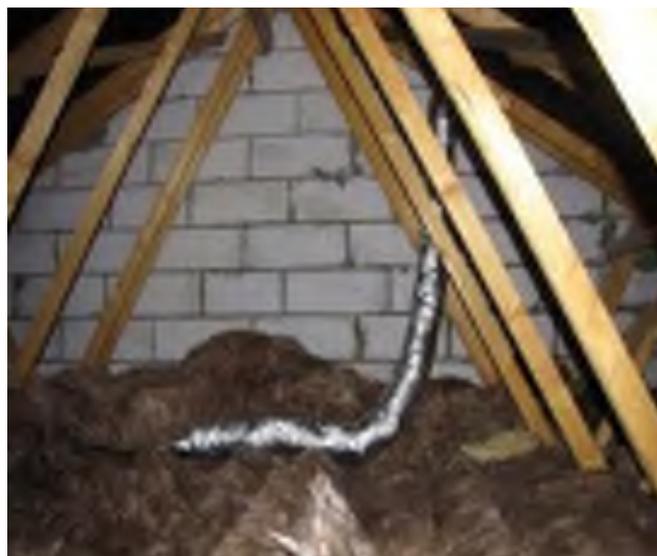
Ducting at Site 3 – Long looping ducting could cause condensation to build up and increase the required fan power

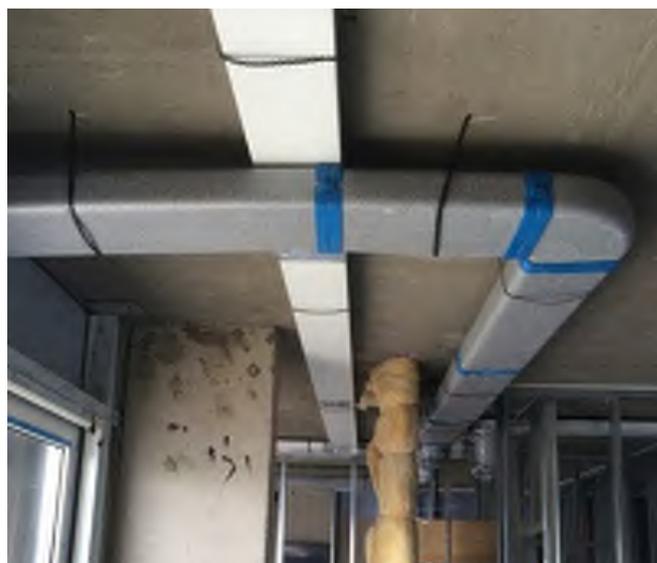
Ducting at Site 2 – Rigid duct installation. Straight duct runs using proprietary bends where needed. Intake/exhaust ductwork is pre-insulated (grey ducting). Ducting mechanically connected and fastened throughout

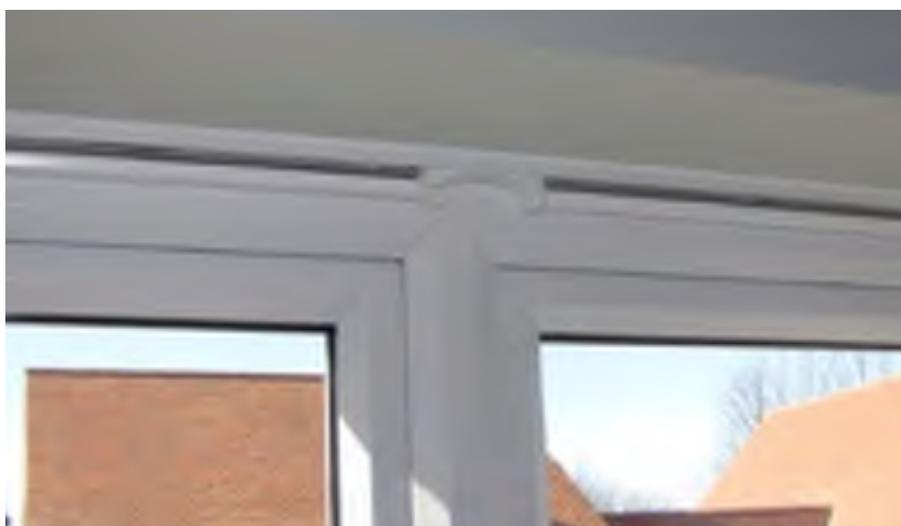
Site 1	No. All the windows installed had trickle vents, including the wet rooms. This was thought to be an error by the window supplier. There was also more than double the Equivalent Area required (see image below).
Site 2	Yes. The window company provided the correctly specified windows with no trickle vents as these are not required for an MVHR strategy.
Site 3	No. Contrary to the design, all the windows installed had trickle vents, including wet rooms. The units had nearly four times more Equivalent Area than required.
Site 4	Yes. The design of the trickle vent sizing and provision closely followed guidance in ADF.
Site 5	No. All the windows installed had trickle vents, including wet rooms.
Site 6	Partially. Trickle vent sizing and provision closely followed guidance in ADF. However the Equivalent Area size of ventilators selected were larger (4000mm ²) and more appropriate for naturally ventilated dwellings.

Trickle Vents at Site 1 – Over-provision of trickle vents at Site 1. Two ventilators fitted with approximate EQA of 5800mm². One trickle vent with EQA of 2500 mm² would meet ADF guidance.

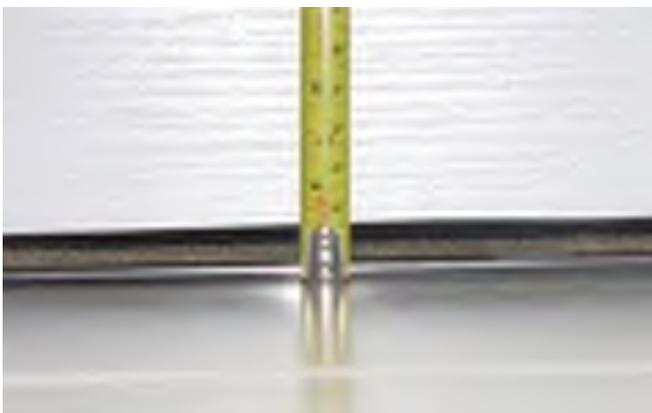
Site 1 – Example of sufficient door undercut: 15-20mm between carpeted and non-carpeted floor finishes – to allow 10 mm above carpet finish for undercut

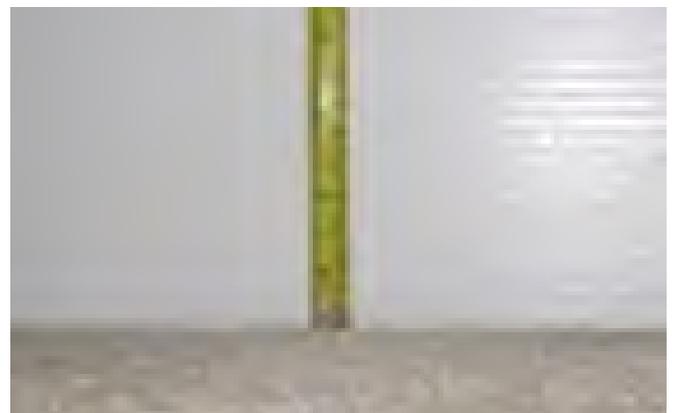
Site 1	No. Door undercuts were inconsistent. Approximately 20% of internal doors had door undercuts of <10mm in all the dwellings inspected.
Site 2	No. Door undercuts were inconsistent. Many were <10mm in the dwellings visited.
Site 3	No. Door undercuts were inconsistent. The Site Manager was unaware of the requirement for door undercuts. Approximately 35% were <10mm in the dwelling tested.
Site 4	No. Door undercuts were inconsistent. The majority were <10mm in all dwellings visited.
Site 5	No. Door undercuts were inconsistent. The majority were <10mm in all dwellings visited.
Site 6	No. Door undercuts were inconsistent. The majority were <10mm in all dwellings visited.

Site 1 – Example of inadequate door undercut

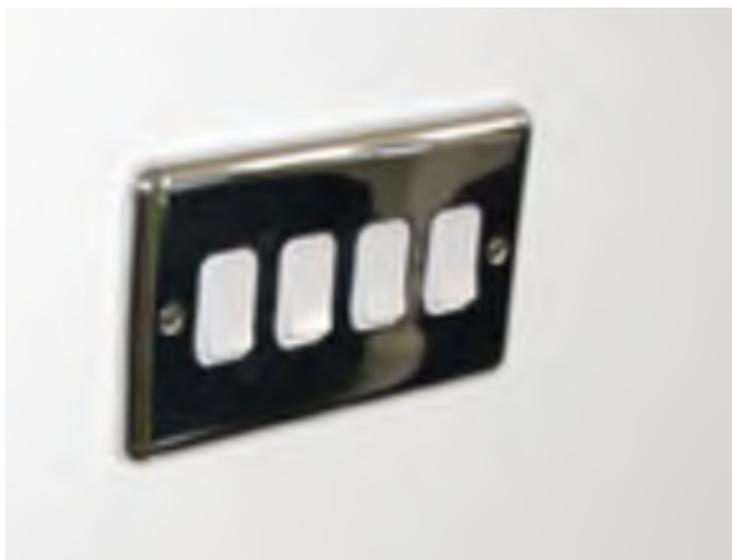
Site 4 – Example of multi-gang switch. One of these is to boost the fan, but there is no labelling to tell the user which one

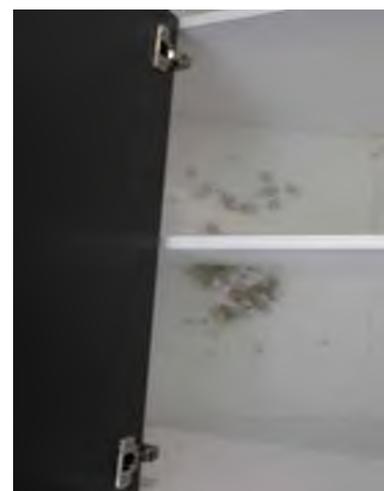
Mould in a cupboard in the Show Home at Site 3 – Example of the risk of under-ventilation, including during building drying-out phase. Sales staff had closed all the trickle ventilators and switched off fans

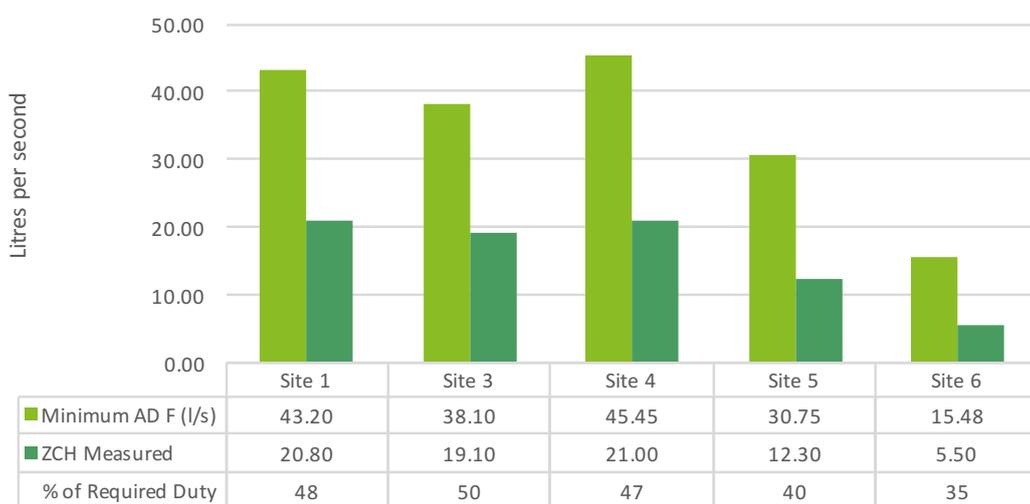
Chart 1a – MEV Measurements – Normal Setting

As chart 1a illustrates, none of the measured extract flow rates in any of the 5 dwellings met the minimum ADF values. The percentage of duty required is shown in the chart (light green stacks). Site 6 only delivered 35% of the required duty, whereas the best site, Site 3, delivered just half (50%) of the required duty.

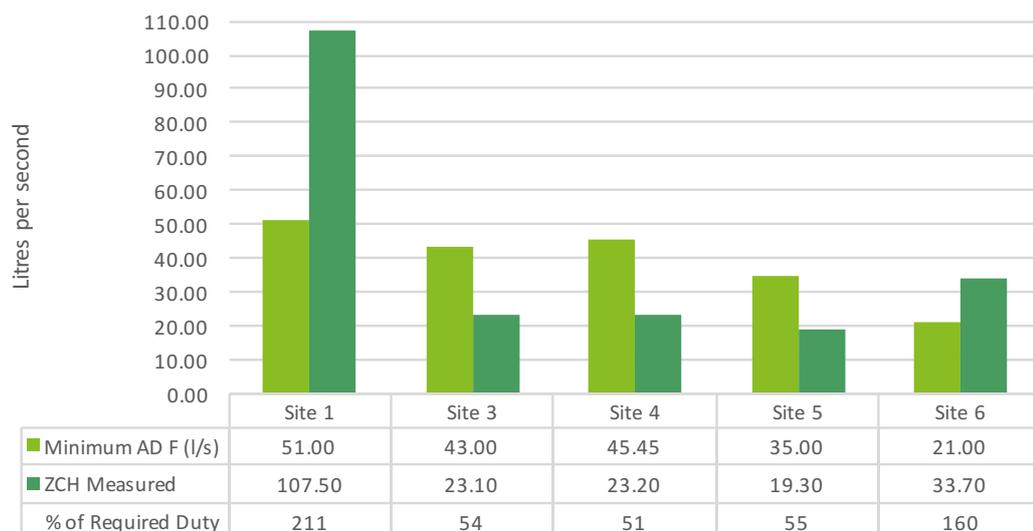
Chart 1b – MEV
Measurements – Boost
Setting

Chart 1b gives the minimum whole-dwelling extract flow according to table 5.1a (ADF). The minimum high extract rates for each room should be:

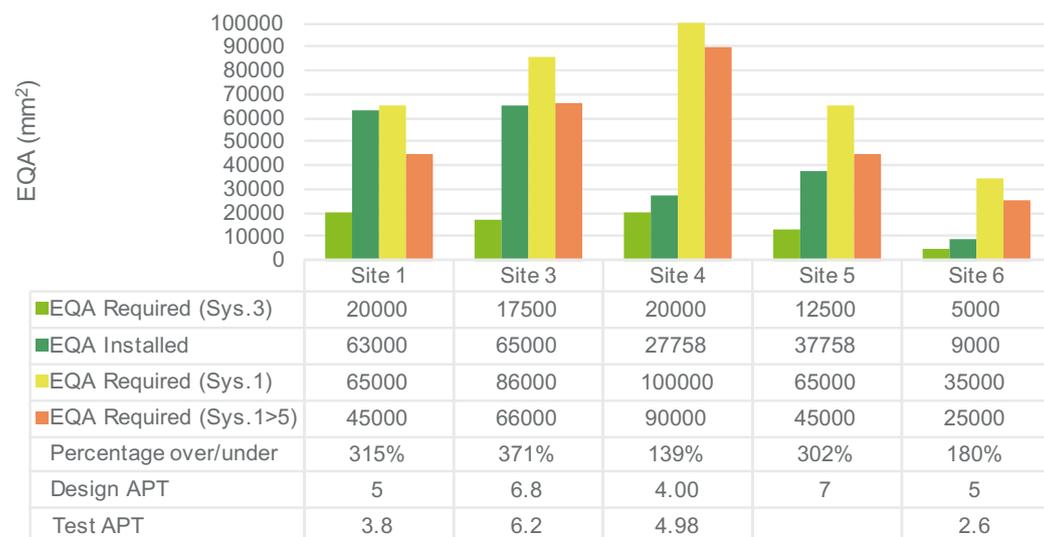
Chart 1c – Background Ventilator Equivalent Areas

The light green stack shows the background ventilator Equivalent Area (EQA) required in each property, based upon the 2500 mm² requirement published in ADF. The darker green stack, adjacent, shows the total EQA installed in each dwelling.

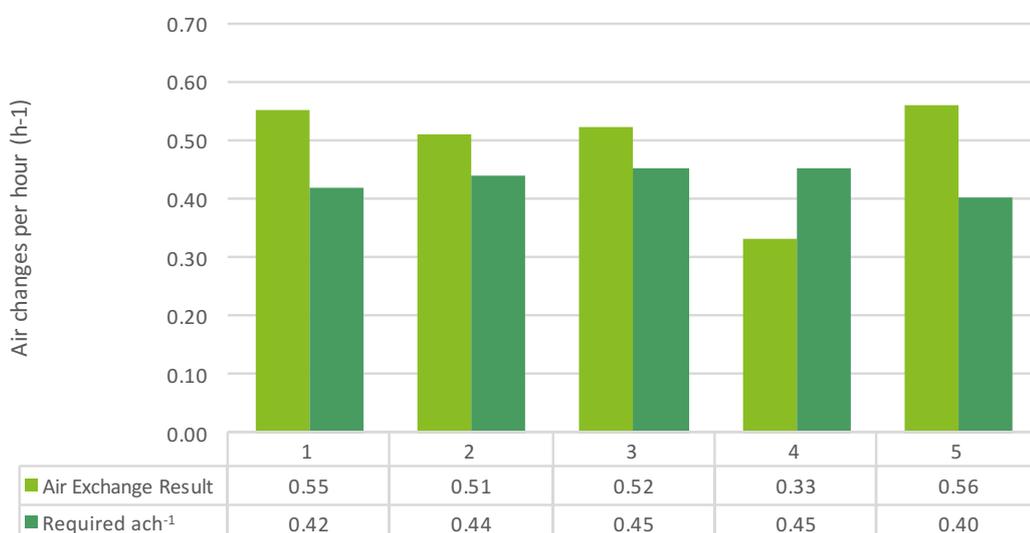
Chart 1d – MEV Air Flow and Air Exchange Measurements

As can be seen, despite the low performance of the fans demonstrated above, the measured air exchange rate is slightly better than the minimum required in all but Site 5 – this being the most sheltered of the sites, with the lowest wind speed on the day of measurement. Site 4, which had broadly the correct amount of ventilators, had a better than expected air exchange rate, but was also the most exposed (coastal/hilly) of all dwellings tested.

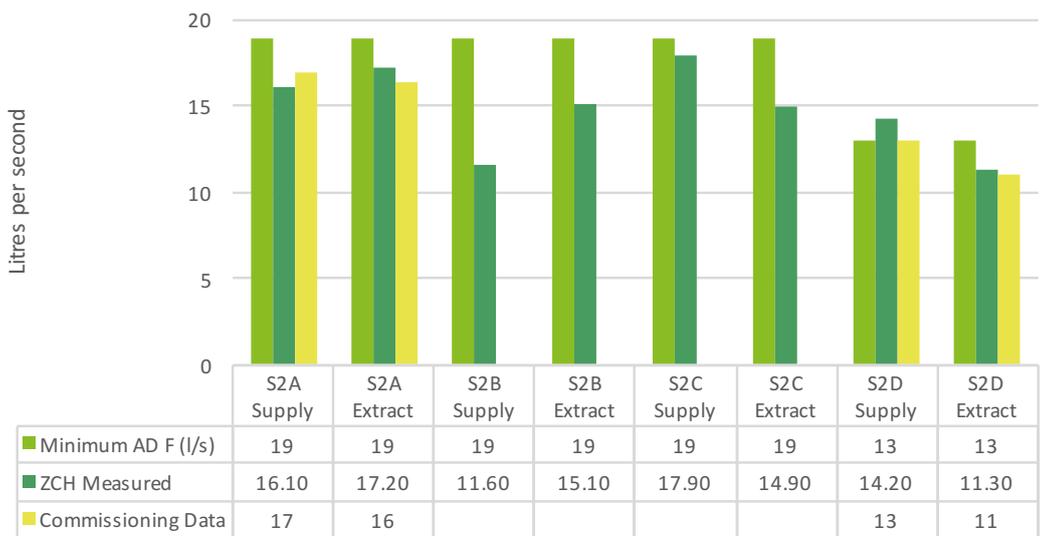
Chart 2a – MVHR Measurements – Normal Setting

Four MVHR-ventilated flats were reviewed, all within one development. The measurements taken during the field visits (dark green stacks) show that the measured air flow rates are less than the minimum recommended by ADF, with the exception of the supply air for flat S2D.

Commissioning values were only available for flats S2A and S2D, which showed a correlation with the values observed during the field visit. However, the commissioning data shows that the systems had been set to operate slightly below the minimum ADF requirement.

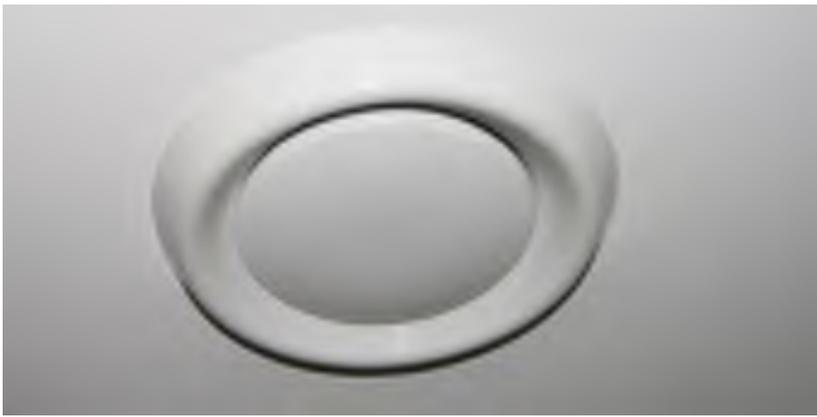
Visual inspection of each of the systems revealed an uncharacteristic finding in that all of the room air terminals were closed too tightly, with an air gap of between approximately 1-2mm around the valve opening, as the photo over the page indicates.

Site 2 – Example of room extract air terminal with inadequate air gap setting, leading to higher flow resistance and localised air velocity noise

The consequence of this tight setting is that, to achieve the air flow rate values, the fan speeds for both supply and extract needed to be set to higher speeds to overcome this resistance, thus the systems will be using more electrical energy than is necessary. The high fan speeds will likely cause noise nuisance.

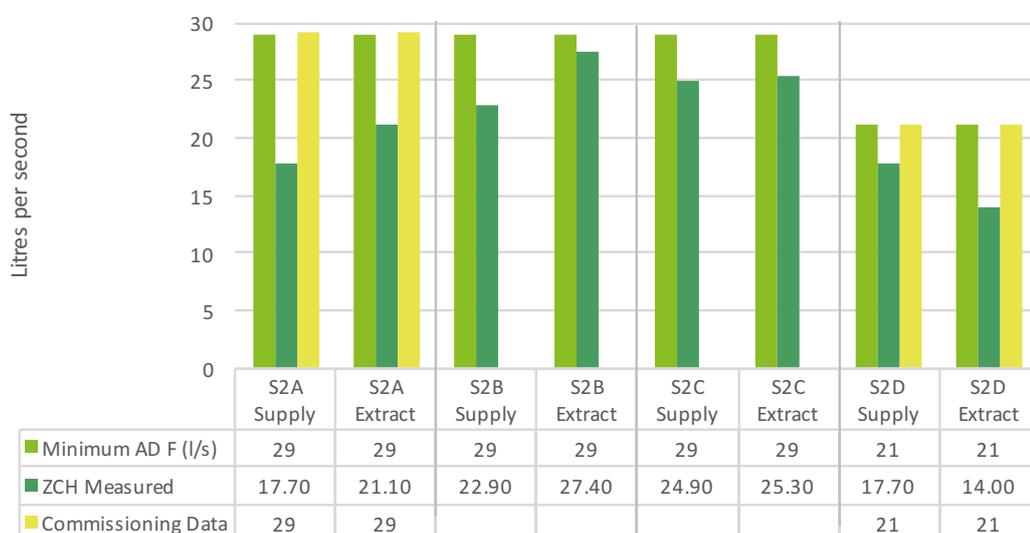
Chart 2b – MVHR Measurements – Boost Setting

The issue of the inadequate air gap setting on the room terminal valves is exacerbated with the increase in fan speed from normal to boost setting. In each flat, the fan settings for the MVHR in boost were set to near maximum capacity (45 l/s), whereas Chart 2b indicates the highest whole-dwelling flow rate (minimum ADF) in boost to be 29 l/s. However, the air flow rates measured by the project team range from as low as 14 l/s to 27.4 l/s, with none of the systems meeting the minimum ADF specification. It was also observed that the sound levels from the systems increased.

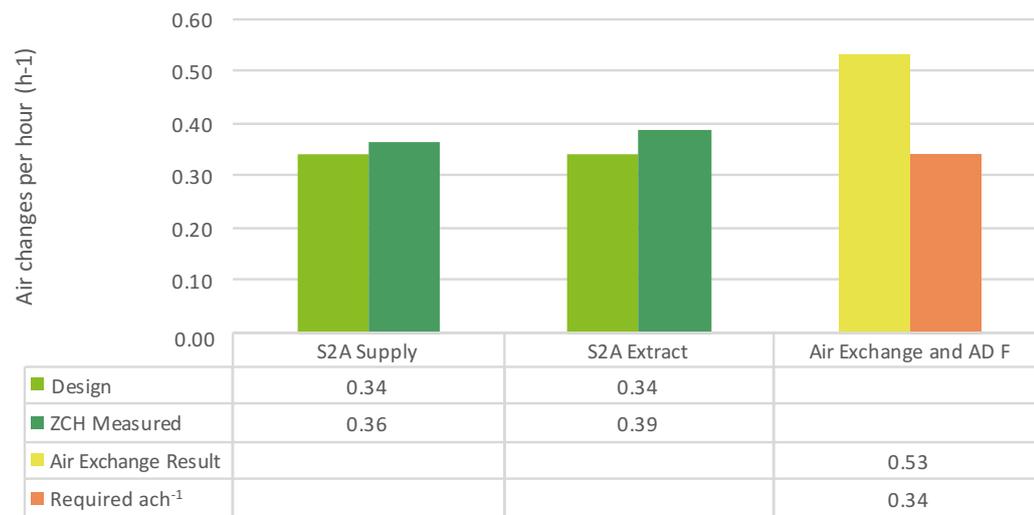
Chart 2c: Site 2 Plot A: MVHR Air Flow and Air Exchange Measurements

An air exchange measurement was carried out in one flat on the MVHR development (S2A). The results are shown in Chart 2c, along with the MVHR design (light green stack) and measurement data (dark green stack) which has been converted into air exchange rates for comparison. The orange stack indicates the calculated minimum air change rate, based upon the requirement of 0.3 l/s per m² in ADF. The air exchange measurement was performed with the system in normal speed setting.

As illustrated, the minimum air exchange rate (0.34 ach⁻¹) is met by the MVHR system. However, a further 0.19 ach⁻¹ was measured, giving a total measured value of 0.53 ach⁻¹. The additional air exchange is likely due to the air leakage of the flat (3.8 m³/(h.m²) @ 50Pa) and the effect of wind on the ventilation system. The flat subject to this test was on the fourth storey and on a coastal location. Thus wind (approx. 1 m.s⁻¹ during the test) and exposure will influence the total air exchange rate.
